## LAYHER Metal Board correction

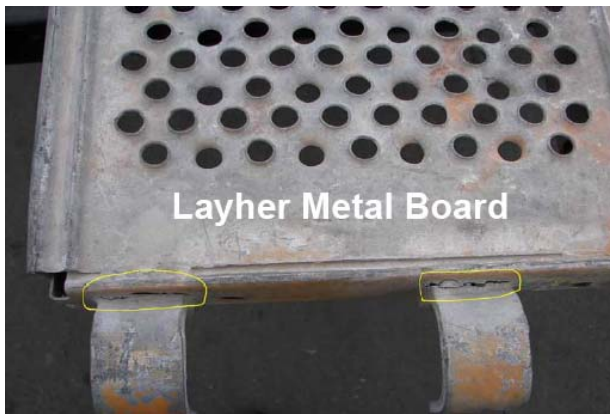
Pic. 1: Picture out of METAL BOARD warning

You might have gotten some information concerning supposed cracked **top** welds on Layher metal boards (see picture below) leading to the allegation that the load bearing capability might be compromised. **This is incorrect, there are no top welds on Layher boards, only brittle zinc coat cracked and this does not compromise the boards load bearing at all.**

The cracks shown here **are cracks of the zinc coat only**. While hot dipping the boards in zinc the groove between hook and board fills up with liquid zinc. This brittle zinc can break under severe abuse, but there is no structural degradation at all. These cracks are not cracks in the welded area, in fact **there are no welds at the top of the hooks** at all.

Layher engineered and thoroughly tested the board – hook attachment design and herewith states that the zinc coating cracks do not compromise the load bearing of the board in any way. Layher is well known for its high quality and good craftsmanship and grants best products.

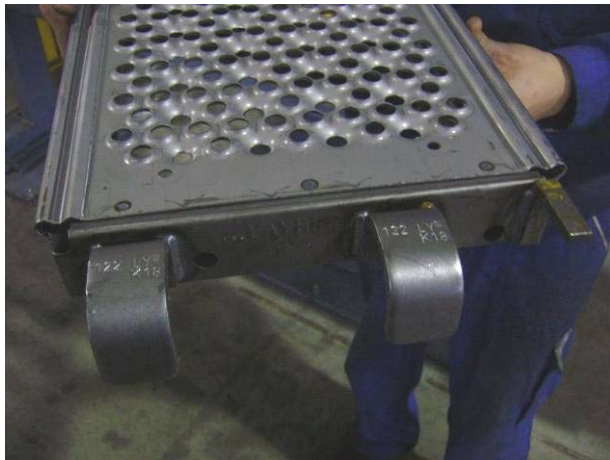
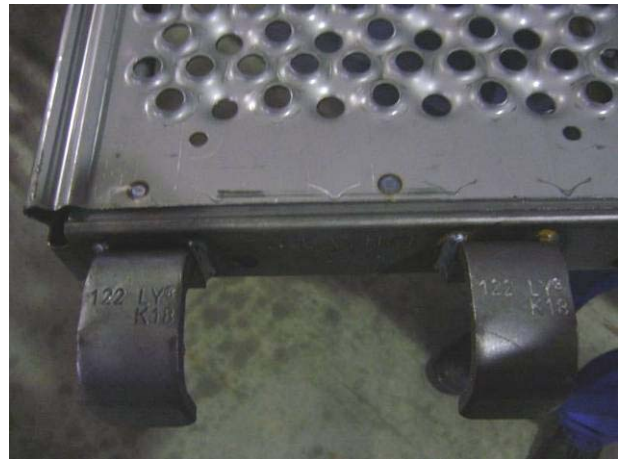
Pic. 2 and 3: Metal board after welding and before zinc coating – **NO TOP WELD ON HOOKS!**

Please see below picture right after welding before zinc coating:

On these pictures it is clearly visible that there is no top weld by design.

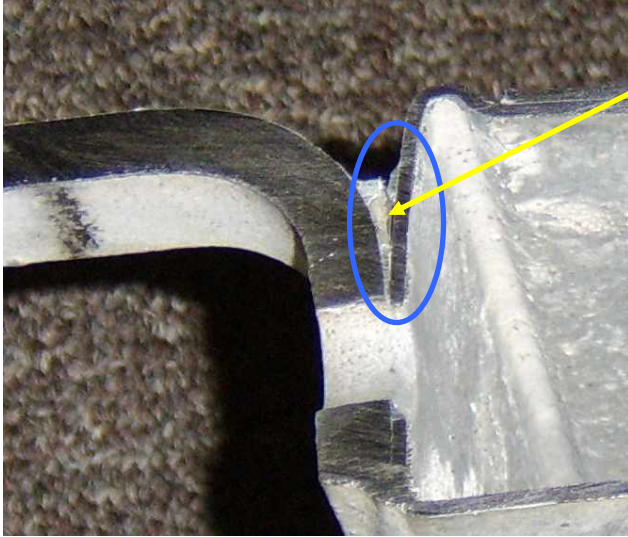
Pic. 4: Section cut through middle of hook. Clearly shows the brighter zinc drip.
